Date: April 14th, 2020
Bulletin#: TB2020-02

Technical Bulletin Regarding: Blower Speed Fault

Applicable Models: All Intellihot Models, most affected are iQ751, iQ1001, and iQ1501

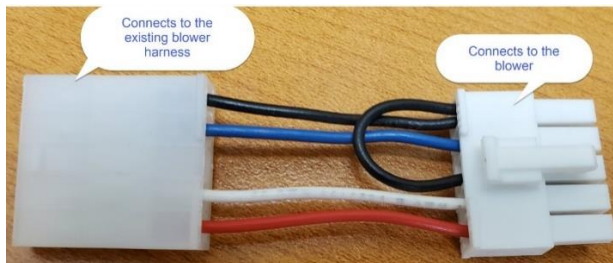
This bulletin is to address blower faults that were previously misdiagnosed. When blower speed faults are shown on the display, error history, or logged in the telliCare system, one of the root causes is signal noise. The signal/electrical noise causes the control board to report an erroneous blower speed fault.

Intellihot has a jumper harness (Part# ELC0305) that connects to the existing wiring harness and eliminates the electrical noise. This connector allows for easy field installation. Please refer to MNL0051 for installation instructions of ELC0305.

Not all units in the field will have signal noise. Most affected models are iQ751, iQ1001, and iQ1501 only. Our recommendation is to add the ELC0305 when there is an issue with the blower (or intermittent cascading fault). If there are any questions or concerns, please contact the Intellihot technical support department, 1-877-835-1705 or support@intellihot.com
